Exhibit A – Pictures of Existing Conditions

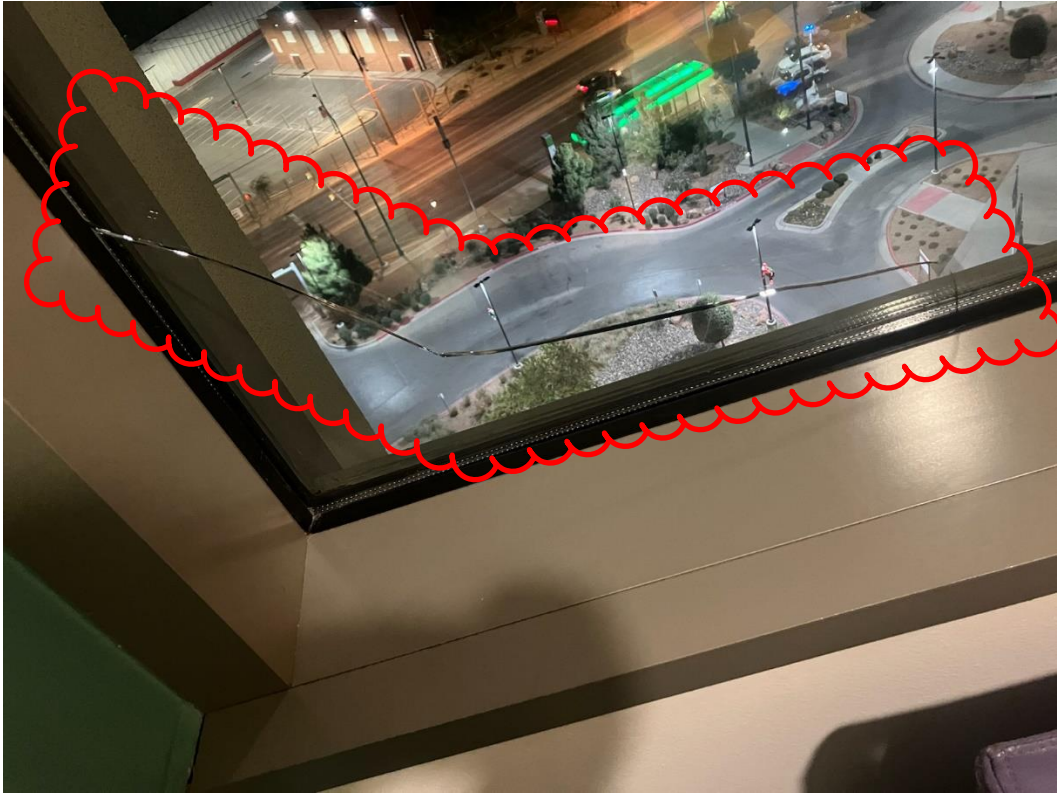
Picture 01 – Close up of Window Crack.
